Behnke Inspection Services, LLC

Sample Property Inspection Report

Property address: **Your Address**

Inspection date: **Thursday, January 01, 2015**

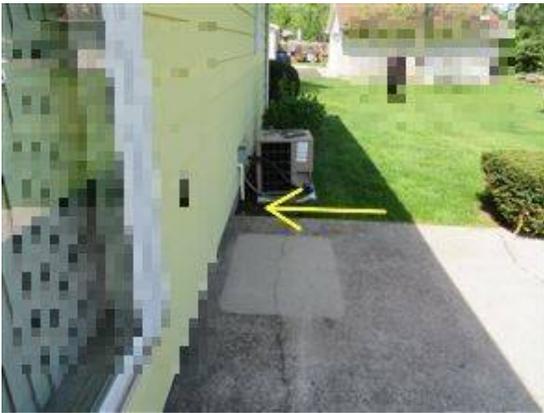
Photo 1-1

The soil or grading sloped downward towards building perimeter in one or more areas. This can result in water accumulating around building foundation or underneath buildings. It is a conducive condition for wood-destroying organisms. Recommend grading soil so it slopes downward and away from building with a slope of at least 1 inch per horizontal foot for at least 6 feet out away from building.

Soil slopes toward building.

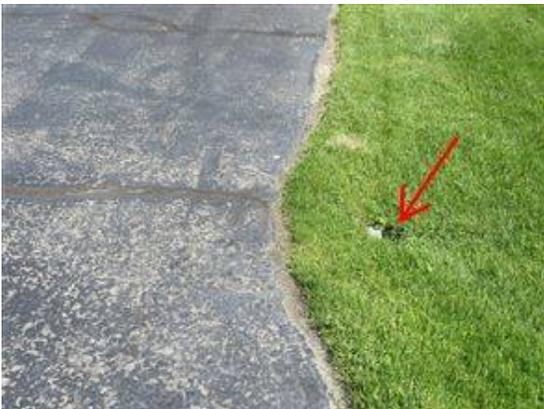
Photo 2-1

Driveway culvert at street is nearly blocked by topsoil. Suspect poor storm water drainage due to poor water flow through culvert.

Top of culvert shown.

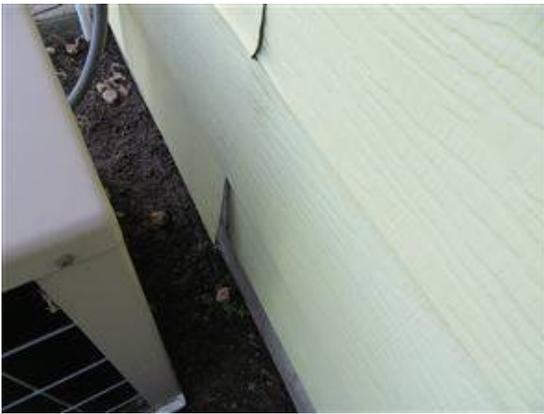
Photo 3-1

Loose sections of siding present. Recommend that a qualified person reattach siding as necessary.

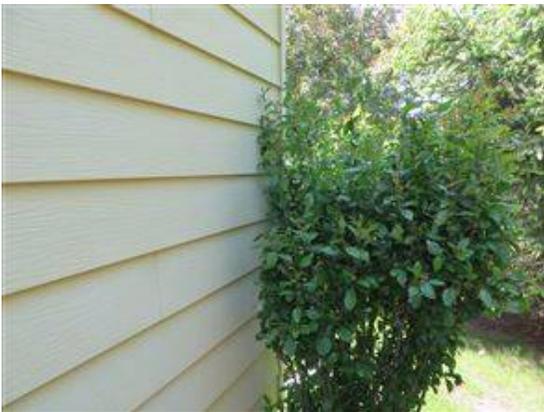
Photo 4-1

Vegetation such as trees, shrubs and/or vines are in contact with or close to the building exterior. Vegetation can serve as a pathway for wood-destroying insects and can retain moisture against the exterior after it rains. This is a conducive condition for wood-destroying organisms. Recommend pruning, moving or removing vegetation as necessary to maintain at least 6 inches of space between it and the building exterior.

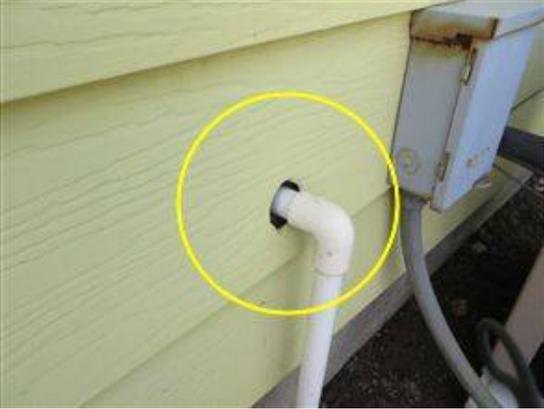
Photo 5-1

Caulk was missing or was deteriorated in some areas. For example, around windows, at wall penetrations. Recommend that a qualified person install caulk as necessary. Where gaps are wider than 1/4 inch, an appropriate filler material should be installed first

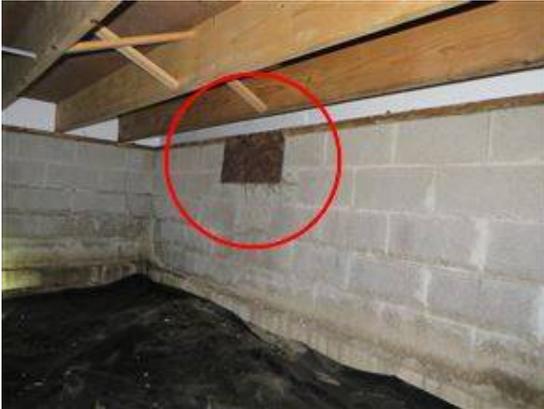
Photo 6-1

One or more crawl space vents were intentionally blocked (e.g. removable panels, rigid foam) from inside the crawl space. This restricts ventilation and free air movement in the crawl space. This may lead to increased levels of moisture inside. Damp, moist crawl space environments are conducive to wood-destroying organisms. Crawl space vents should be left open except during cold winter months. Recommend removing materials or items used to close or block vents.

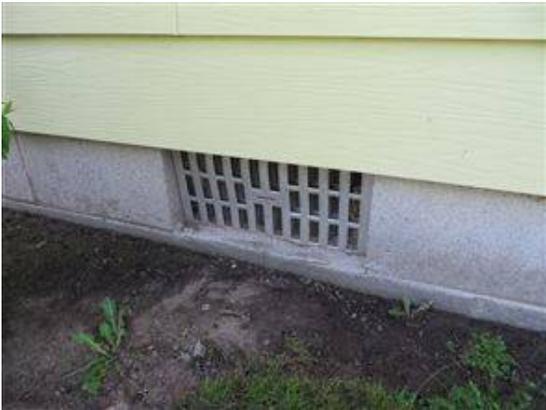
Photo 7-1

The screens for one or more crawl space vents were missing or damaged. Vermin or pets can enter the crawl space and cause damage. Recommend that a qualified person install or replace screens where necessary using 1/8-inch to 1/4-inch wire mesh.

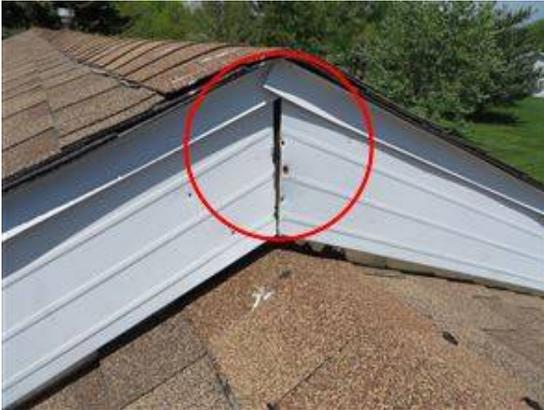
Photo 8-1

Fascia trim at peak of roof between house and garage portion has a gap that exposes the underlying wood to the elements. Suitable fascia covering material should be added to cover this gap. Prolonged exposure of the underlying wood may result in wood decay/rot and is conducive to wood destroying organisms.

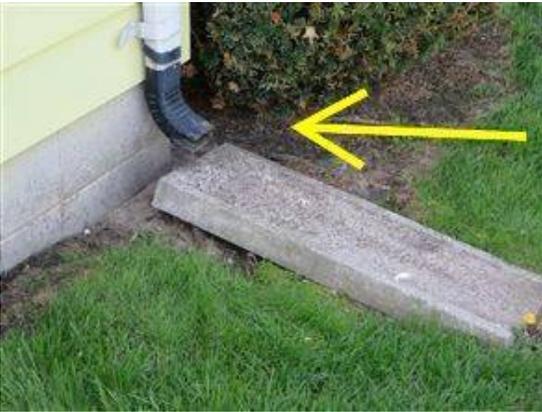
Photo 9-1

Extensions such as splash blocks or leaders for one or more downspouts are too short, missing or poorly sloped. Rain water can flow back and accumulate around the building foundation or inside crawl spaces or basements as a result. Recommend installation of downspout leaders to direct water away from house at least 6 feet.

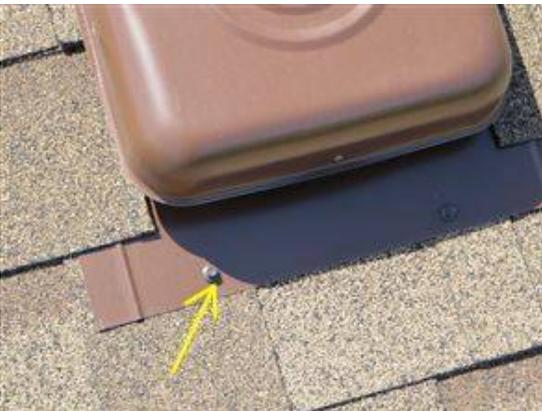
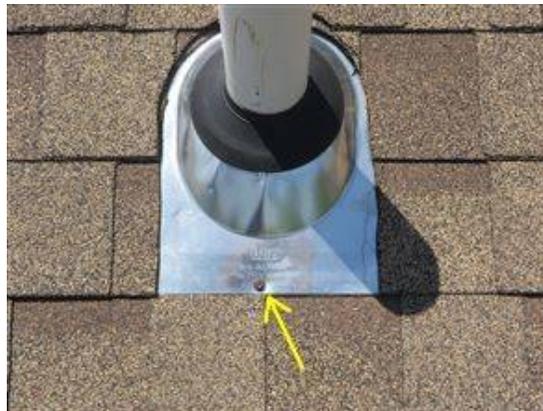
Box vents and plumbing stack vents on roof have exposed fasteners. Sealant should be applied over fasteners to prevent leaks.

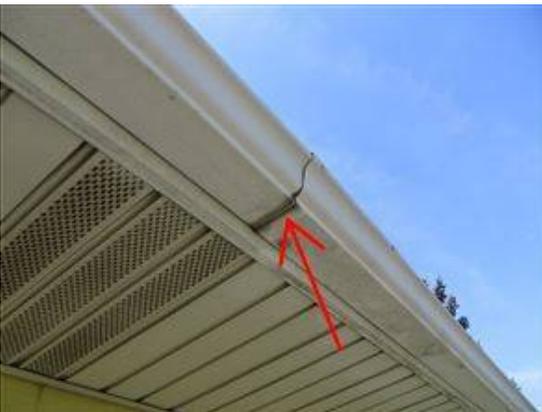
Photo 12-1

Gutters are not continuous one piece type. Water staining was found at joints. This is an indication of past or current leaks. Recommend evaluation of gutters during rain event and repair if required.

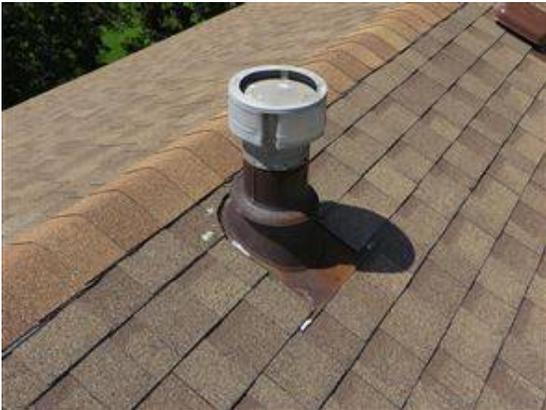
Photo 13-1

Furnace chimney and flashing is rusted. Recommend professional evaluation and repair or replacement as required.

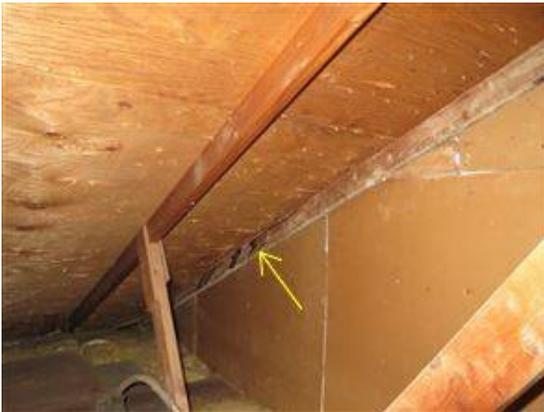
Photo 14-1

Old water stains were visible on the roof structure at one or more locations in the attic. However, no elevated levels of moisture were found at these stains during the inspection. The stains may have been caused by a past leak. Recommend asking the property owner about past leaks. Monitor these areas in the future, especially after heavy rains to determine if active leaks exist. If leaks are found, recommend that a qualified contractor evaluate and repair as necessary.

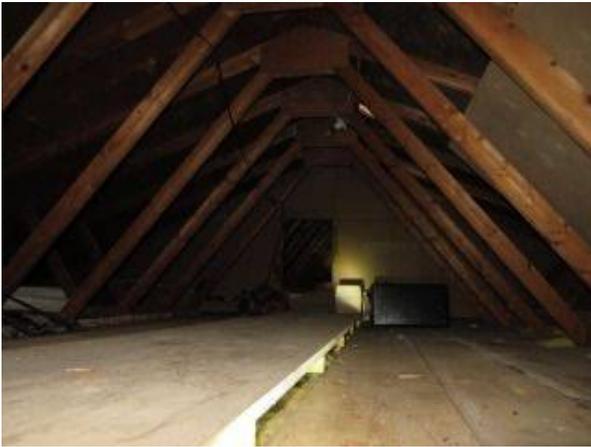
Photo 15-1

Stored items and flooring for storage was found above top of bottom chord of garage roof trusses. Trusses are engineered components designed specifically for the weight of the roof structure and external loads such as snow. Flooring materials compress the loft of insulation, limit the quantity of insulation installed, and adds additional weight or load to the roof/ceiling structure. This additional loading is usually not considered when choosing trusses for a roof assembly. Recommend removal of flooring and any stored items in attic.

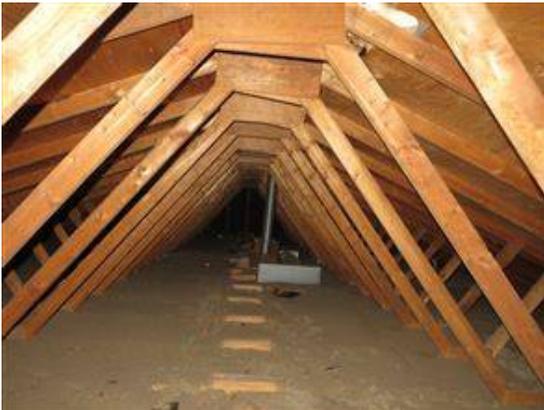
Photo 16-1

The amount of ceiling insulation installed in the attic is less than recommended amount for this locality and has an R-value significantly less than suggested R-value (R-38). Heating and cooling costs will likely be higher due to poor insulating efficiency. Recommend adding additional insulation for better energy/thermal efficiency.

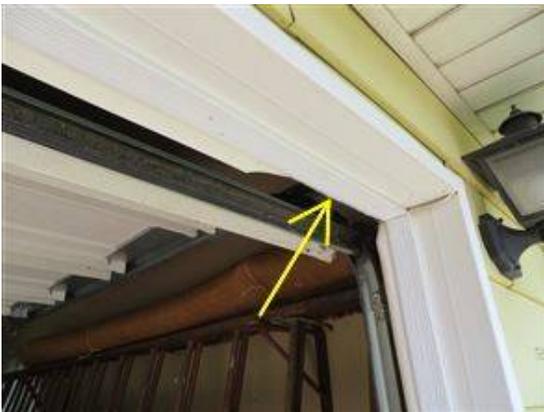
Photo 18-1

Weatherstripping at the sides and/or bottom of the garage door are damaged or deteriorated. Recommend adding or installing new weatherstripping where necessary to prevent water intrusion.

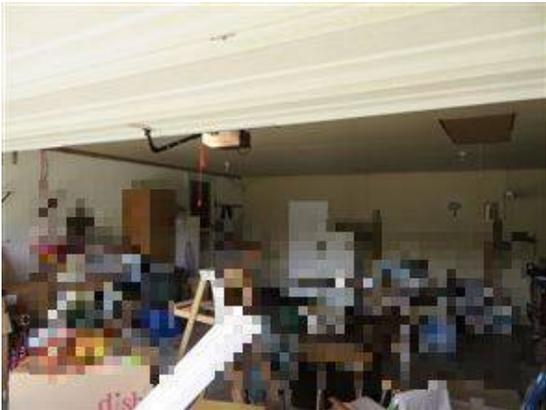
Photo 19-1

Some wall and floor areas in garage were obscured by stored items and couldn't be fully evaluated.

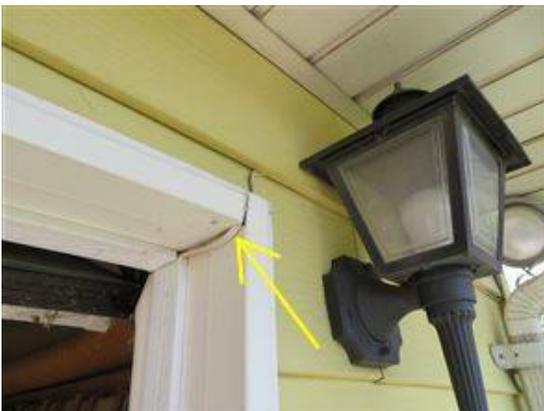
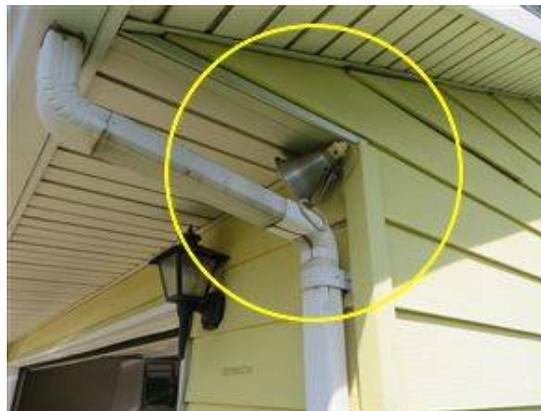
Inappropriate wiring and light fixture were found outside near the garage door. Exposed wiring is used as permanent wiring. Wiring is inappropriate for use. Wire sheathing may become abraded and present electrocution hazard. This is a safety issue. Recommend that a qualified electrician evaluate and repair as necessary and per standard building practices.

Photo 20-1
Improper permanent wiring shown.

Photo 20-2
Improper outdoor light in use.

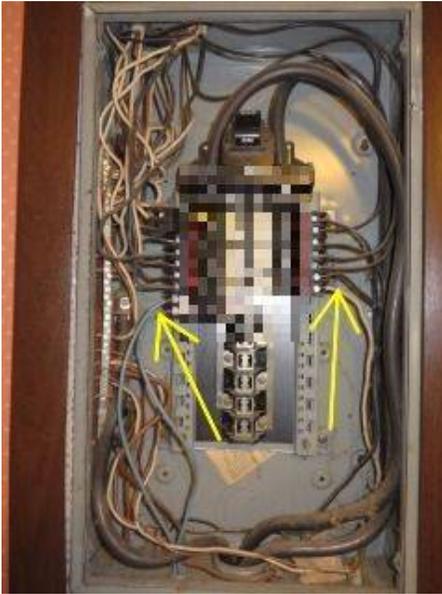
Photo 22-1

The ungrounded conductors are not identified where they connect to breakers in the circuit panel. Conductors should be identified properly by qualified professional and marked accordingly.

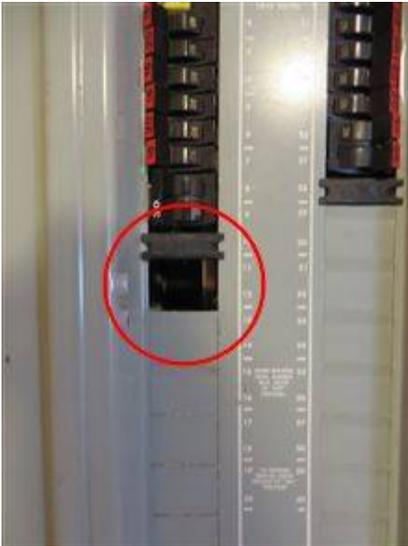
Photo 23-1

One or more open slots where circuit breakers are normally installed were found in panel(s) #A. Energized equipment is accessible to touch and is a shock hazard. Recommend that a qualified person install slot covers where missing.

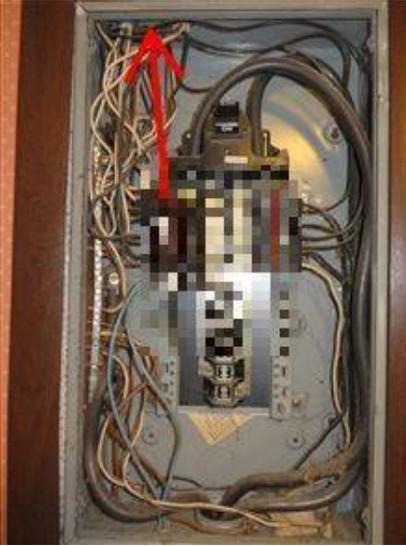
Photo 24-1

One or more conduit knockouts were missing from inside panel(s) #A. This has allowed insulation to fall into the panel box from above. Holes in panels are a potential fire hazard if a malfunction ever occurs inside the panel. Rodents can also enter panels through holes and chew on wires or build nests. Recommend that a qualified person install knockout covers where missing and per standard building practices.

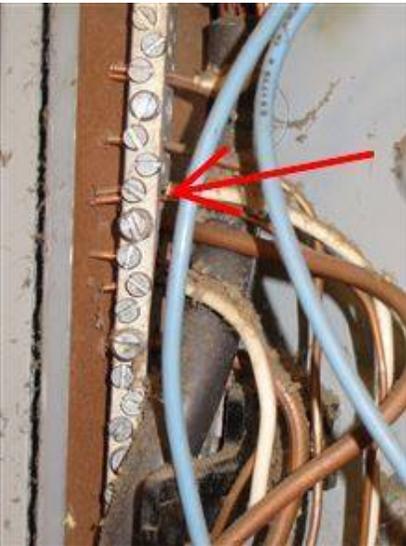
Neutral and ground wires were doubled or bundled together under the same lug on the neutral/ground bus bar in panel(s) #A. Multiple wires under the same lug may not be secure, resulting in loose wires, arcing, sparks and fire. This is a safety hazard. Recommend that a qualified electrician repair per standard building practices. For more information, visit: <http://www.reporhost.com/?DTNB>

Photo 25-1
Double tap shown

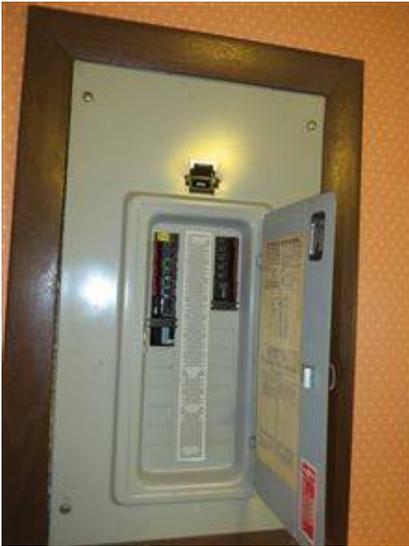
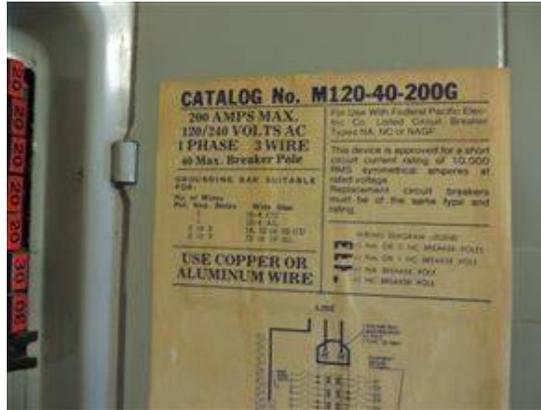
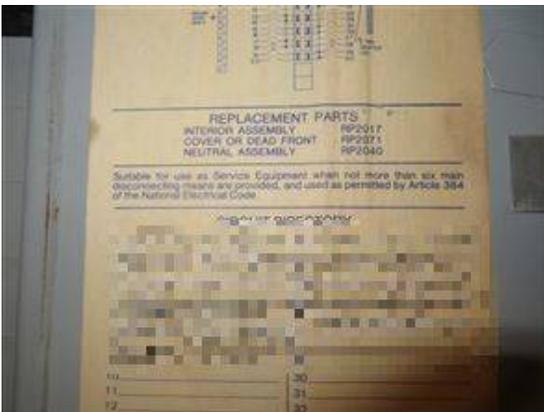
Suggest further evaluation of electric panel by licensed professional electrician to determine condition of electric panel. Panel(s) #A was manufactured by the Federal Pacific Electric company and used "Stab-Lok" circuit breakers. There is significant evidence that both double and single pole versions of these circuit breakers fail by not tripping when they are supposed to. However, in 2011 the Consumer Products Safety Commission (CPSC) closed an investigation into this product because they did not have enough data to establish that the circuit breakers pose a serious risk of injury to consumers. Consider replacing Federal Pacific panels with modern panels that offer more flexibility for new, safer protective technologies like ground fault circuit interrupters (GFCIs) and arc fault circuit interrupters (AFCIs). For more information, visit:

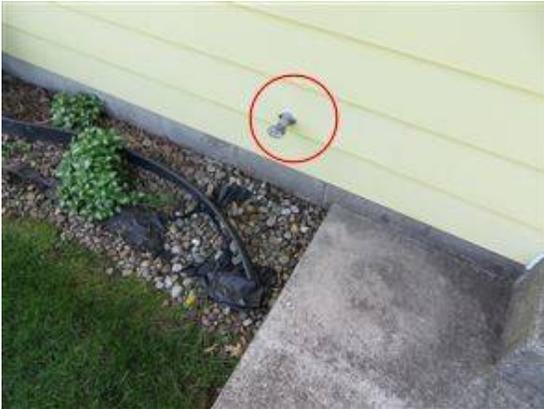
Photo 30-1

30) + One or more hose bibs (outside faucets) were missing backflow prevention devices. These devices reduce the likelihood of gray water entering the potable water supply through backsiphonage. Recommend installing backflow prevention devices on all hose bibs where missing. They are available at most home improvement stores and are easily installed. For more information, visit:

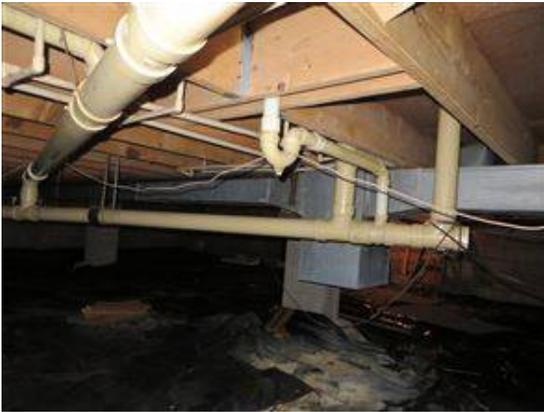
Photo 31-1

31) 🛠️ PVC or CPVC drainage and water supply pipes had inadequate support. Leaks may occur as a result. PVC and CPVC pipes should have supports every 4 feet. Special hangers that allow movement from expansion and that won't damage the soft plastic piping should be used. Recommend that a qualified person install supports or secure pipes per standard building practices.

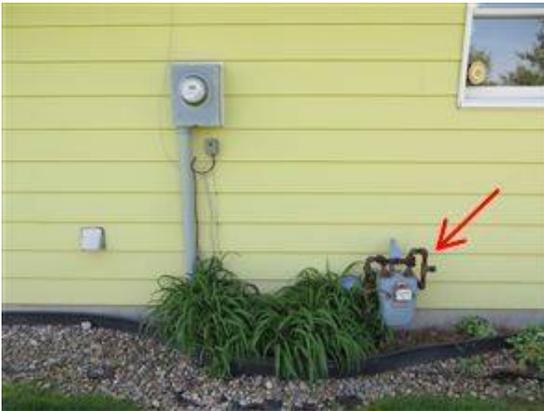
Photo 32-1

Black steel piping for the main gas service located outside was significantly corroded. Gas leaks can result. Recommend evaluation by a qualified contractor to determine if piping needs replacement. Piping should be painted with a rust preventative paint. Very corroded pipes should be replaced by a qualified contractor.

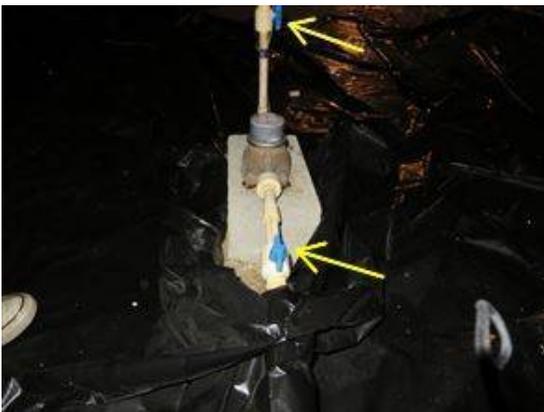
Photo 33-1

Water shut-off valve was located in the crawl space near the water meter. This is an inconvenient location at best, and may prevent the water from being turned off in a timely manner in the event of a plumbing emergency. Consider having a qualified plumber relocate the shut-off valve to a more convenient location, such as in a closet or a cabinet under a sink.

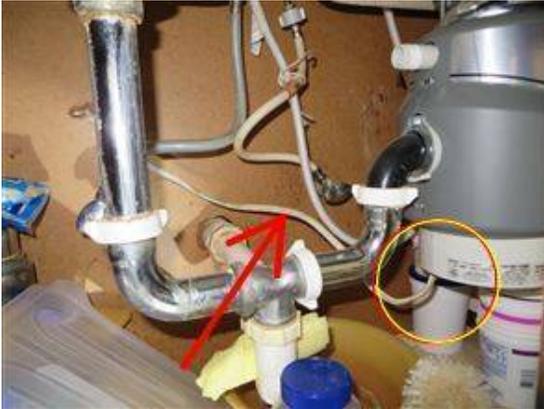
Photo 38-1

Non-metallic rigid sheathed cable wiring used to provide electricity to garbage disposal. This wiring can be damaged by repeated flexing/bending or contact with sharp objects. Flexible metallic sheathed armored conduit should be installed to protect wiring, or a flexible appliance cable should be installed. This is a potential shock hazard and safety issue. Recommend that a qualified contractor repair per standard building practices.

A conduit clamp bushing where electric cable attaches to the food disposal is missing. Insulation on the wiring can get damaged where wires are routed through holes in the under-sink food disposals metal housing. This is a shock and safety hazard. Recommend that a qualified electrician install conduit clamp bushing where missing and per standard building practices.

Arrow points to faulty wiring. Circle indicates location of missing bushing.

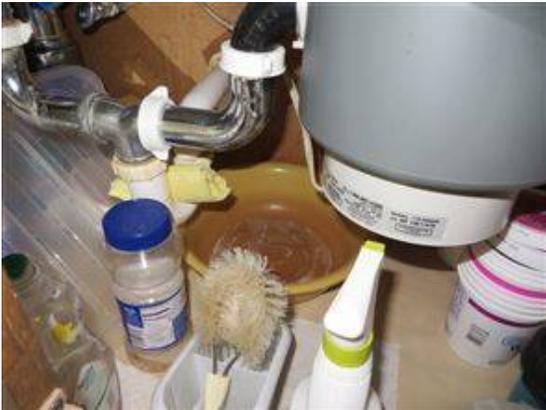
Photo 40-1

Sink drain piping below kitchen sink is leaking slowly. Water is evident when sink drain stopper is removed and water is allowed to drain. Also, disposal and sink share common trap which is improper. Disposal operation with blocked trap could force water into other sink. Recommend a separate trap for the sink and disposal. Recommend leaks and piping be repaired in accordance with normal plumbing practices.

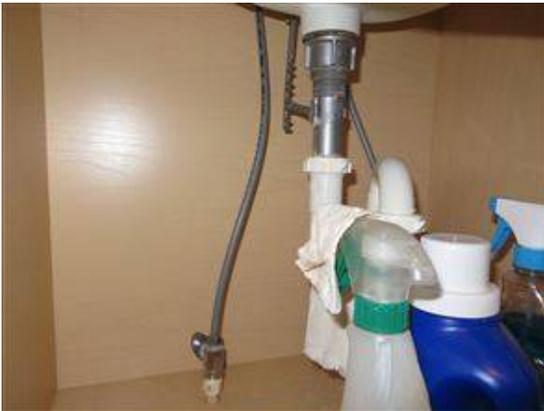
The sink drain pipe at location(s) #C uses an S-trap rather than a P-trap, or no P-trap was visible. Siphons and sudden flows of water in S-Traps can drain all the water out of the trap, leaving it dry. Sewer gases can then enter living areas. Recommend that a qualified plumber repair per standard building practices.

Photo 41-1
Under sink #C

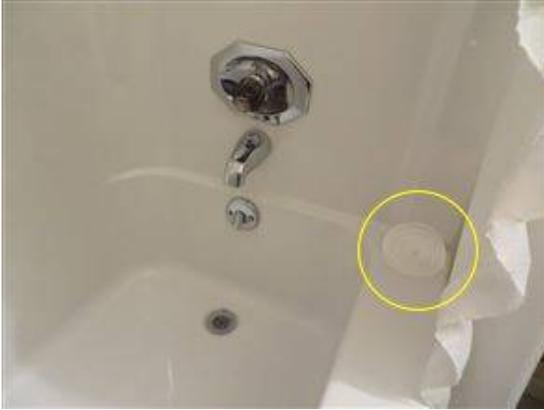
Photo 47-1

Main Bathroom #A The bathtub drain stopper was ineffective. The homeowner uses rubber drain stopper to hold water in tub. Drain stopper needs repair.

Rubber drain stopper at edge of tub shown.

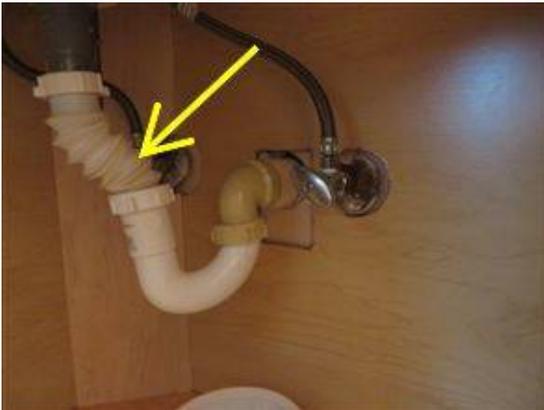
Photo 49-1

Bathroom #B Non-standard trap piping found. Suggest that non-standard piping be replaced with smooth non-corrugated piping for this use. Corrugated piping can inhibit smooth flow of drain water and can encourage build-up of debris in pipe.

Non-standard piping under sink.

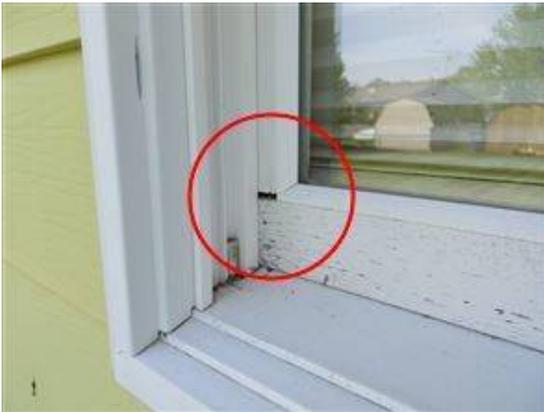
Photo 51-1

Window sash separating at corner. Recommend repair or replacement.

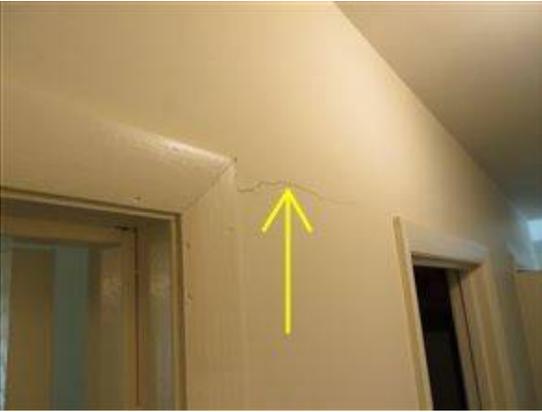
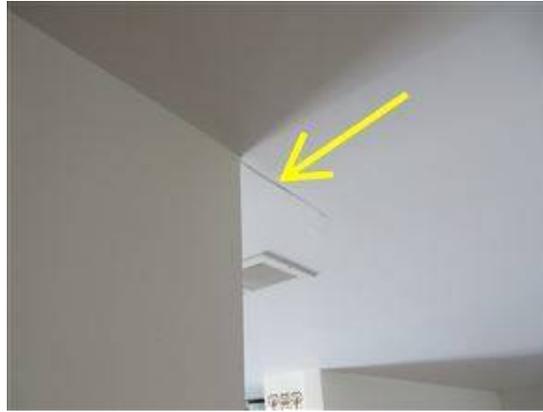
Minor cracks, nail pops and/or blemishes were found in walls and/or ceilings in one or more areas. Cracks and nail pops are common, are often caused by lumber shrinkage or minor settlement, and can be more or less noticeable depending on changes in humidity. They did not appear to be a structural concern, but repair may be desired for aesthetic reasons. For recurring cracks, consider using an elastic crack covering product:

Photo 54-1
Crack in hallway.

Photo 54-2
Crack in ceiling near end of hallway.

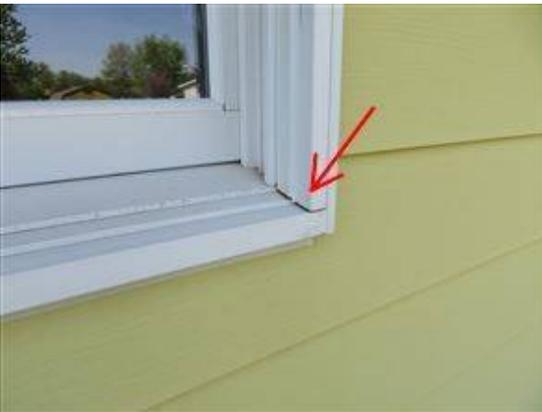
Photo 55-1

Window frames require caulking.

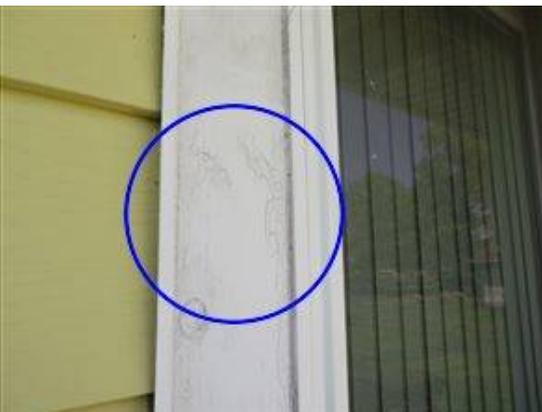
Photo 56-1

Exterior windows and door trim require painting.
